Porsche Carrera Cup France 2026

Note Technique 06/2026

MEMBRANE BOCAL LIQUIDE DE FREIN

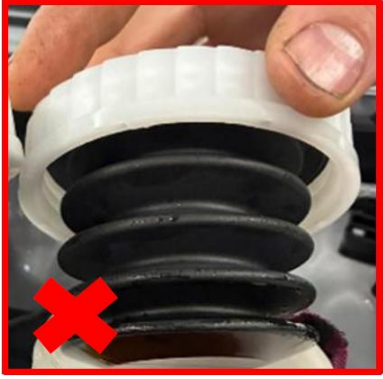
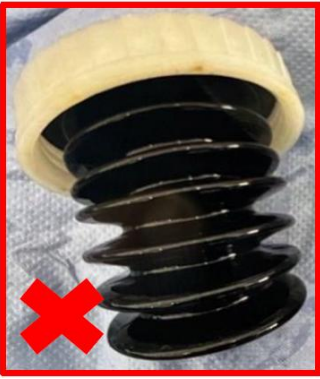
Le système de freinage peut dysfonctionner si les orifices des maitres cylindres sont bouchés.

Membrane trop longue : REEMPLACEMENT nécessaire	Membrane trop longue : REEMPLACEMENT nécessaire	Version correcte : membrane avec 3 soufflets

Si une membrane trop longue (plus de 3 soufflets) est installée dans un des bouchons de liquide de frein, celle-ci doit être remplacé avec la bonne combinaison de bouchon/membrane avant toute prochaine utilisation en piste.

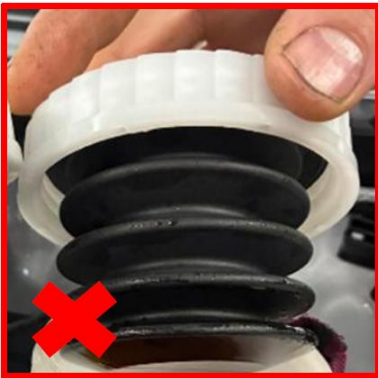
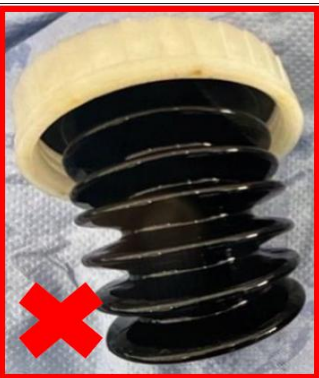
Brake system malfunction due to blockage of the bores in the brake master cylinder.

Bellows too long : MUST be replaced	Bellows too long : MUST be replaced	Correct version : Bellows with 3 ribs

If a longer (more than 3 bellow ribs) are fitted in the brake master cylinder reservoir, these incorrect bellows must be replaced with the correct cap / bellow combination before the car is driven on track again.
